## Geographical Observations and Rock Collection

Casama, Iris Shane N.<sup>1</sup>, Rivera, Sarah Mae M.<sup>2</sup>, and Rizzo, Jade<sup>3</sup>

BACHELOR OF SCIENCE IN BIOLOGY 2A

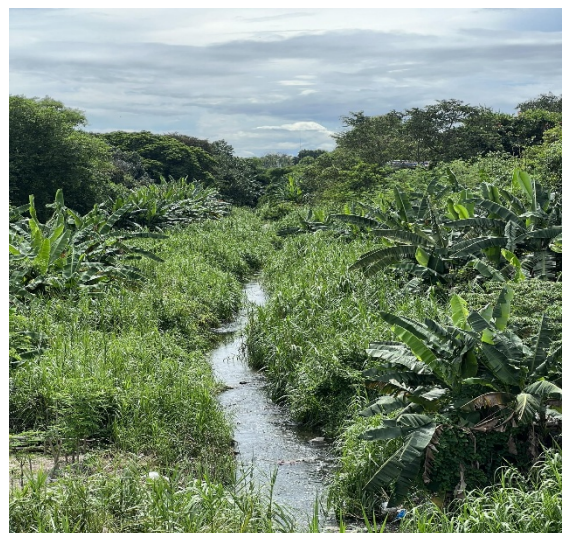
In terms of general geographic observation, the area which was the *Sapang Balen* was full of trash but the fauna and flora of the area was still very rich, the flora were diverse some only knee high and some higher than a meter and the growth were gratifying and compact with no space in between it was especially rich beside the water as when walking the feet can be caught by the flora that have fallen in the water and entangled. In terms of the organisms living in the community of the river, the fauna was also diverse as we observed a number of dragonflies and damselflies which were bio indicators of the quality of the water as well as its health (Seidel, 2019). The researchers have observed fishes, insects such as lady bugs, spiders, and mantis residing in the flora near the water and mollusk, millipede and centipedes, bees and butterflies and ants for among the organisms observed in land.

Figure 1. *Sapang Balen*

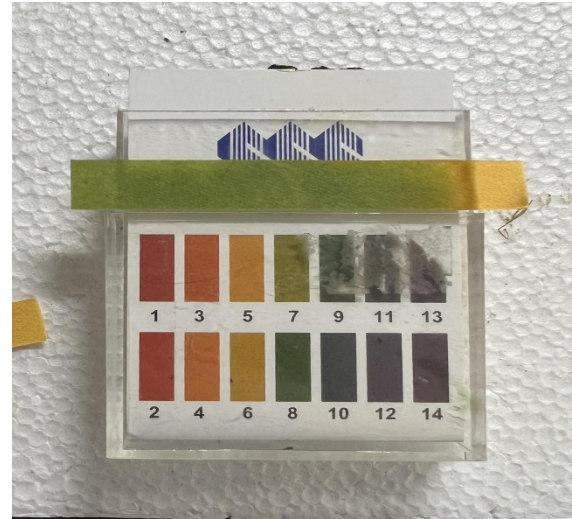
Figure 3. Water Sample pH test

The pH test for the water sample that was taken was at the neutral pH level of 7 (see figure 3) while the pH level of the distilled water was only at pH level of 6 (see figure 4). In this aspect, various factors may be applicable for the pH level of the *Sapang Balen River*, among them are the pollutants that may flow in it and the pollutants that were absorbed by the soil (Mohamed et al., 2018). Another reason may be due to the presence of microalgae the researchers have observed under the microscope as *Chlamydomonas*, as most microalgae grow in a neutral pH and these particular microalgae optimum growth is between the pH of 5.5 and 8.5 (Yu et al., 2022). Another aspect that can be considered would be the relationship of Carbon dioxide and pH as when CO<sub>2</sub> was absorbed and processed into

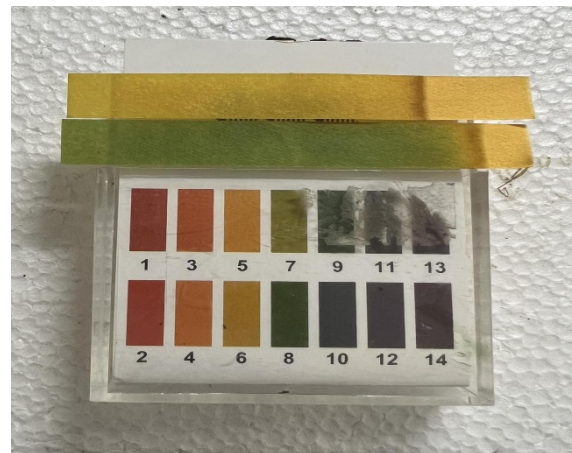
Figure 4. Comparison of Water from river and Distilled water

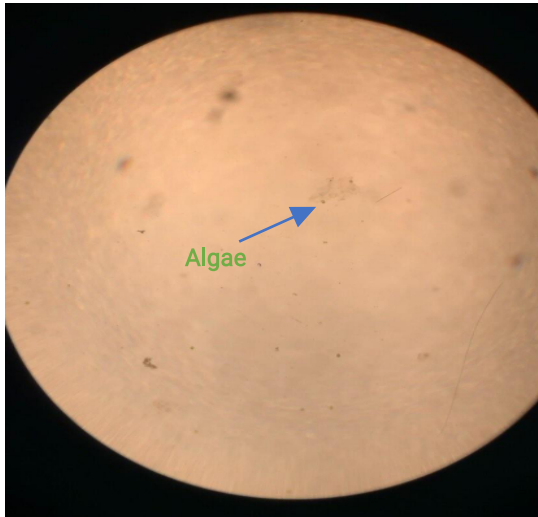
Figure 5. Water sample under microscope

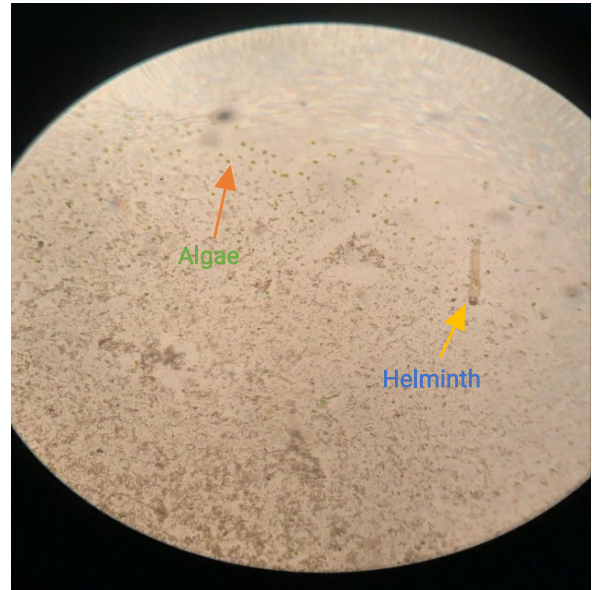
The soil sample when viewed under the microscope showed a microorganism that was planaria like surrounded by *Chlamydomonas*, the organism may have hidden in the sand due to the disturbance when walking in the water. The soil was sandy in the water but more compact and moister in the land surrounding it, which may have helped in the growth of the flora. The preliminary observation and identification of the rock samples the researchers have collected from both land and water showed that most of them are basalt which were igneous rocks that were dark, smooth and fine grained (King, n.d.), some of them showed that they were pumice which were igneous rocks that have rough foam like texture, usually light colored and is form when a volcano explodes and cools rapidly when coming in contact with water (Mat, 2023) the last type observed was a sedimentary rock such as sandstone and limestone which are more common in bodies of waters such as rivers (U.S. Geological Survey, 2012).

Figure 6. Soil sample under microscope

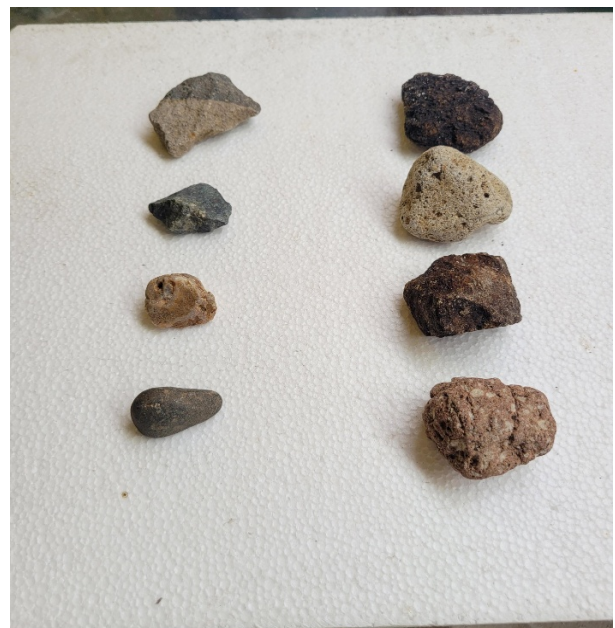
As preliminary identification of the rocks the researchers found showed that most of them were igneous rocks, it may imply that the river may be connected to a volcano or upon explosion of a nearby volcano some particles were mixed with the water which may have formed the rocks and brought them to different area following the flow of the water and the rain.

Figure 7. Rocks Samples from *Sapang Balen*
